# Kavanagh Balloons Service Letter KSL225-02

## Control line defects

This service letter contains details for inspection and rectification for lumps in deflation system control lines.

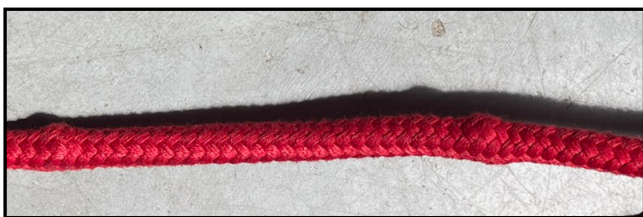
Fig1. Lumps

Lumps are formed when the polyester sheath shrinks relative to the Vectran core. The core then bunches up forming the lump.

Inspect the full length of each deflation system control line for lumps (fig1) or haemorrhage (fig2).

The standard rope diameter is ~9mm. Control lines identified with lumps that are over 12mm in diameter or can't be run through a control line pulley without resistance is grounds for immediate grounding of the aircraft until repairs are carried out.

Control lines with lumps that are under 12mm in diameter and can be run through a control line pulley without resistance may remain in service but must be noted for rectification at or before the next periodic inspection.

Control lines with lumps may be rectified in situ. The following should only need to be done once in the life of the control line as any shrinkage of the sheath should have finished after the first few heating / flight cycles. A maximum of 1000mm of core can be removed from any control line.

- Count the total number of lumps in the control line
- Multiply the number of lumps by 50. This will give a length in mm of core to be removed. ie: 10 lumps = 500mm. Maximum allowed is 1000mm
- Where the number of lumps exceeds 20, attempt rectification with the maximum 1000mm of core removed.
- From one end of the control line, trim the sewn end off and extract the required length of core. Do not cut yet.
- Tie a knot to secure the sheath and core at the end of the control line (fig3), there will be a section of excess sheath bunched up.
- Work the excess sheath along the length of the control line checking that each lump in the core can be smoothed out. Ensure there is not an excess of sheath at either end of the control line.
- If lumps remain, extract a little more core and repeat.
- Trim the core, hot cut the sheath and re-sew the end (fig4) to secure the sheath to the core.

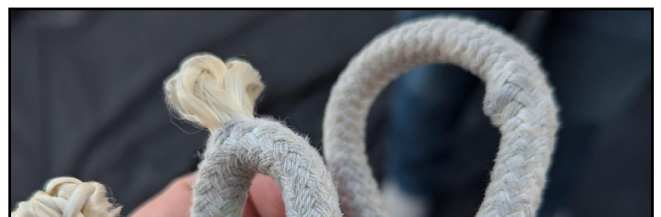
Fig1. Haemorrhage

A number of operators have reported lumps forming in deflation system control lines. If left unchecked, the core of the rope may haemorrhage through the sheath and may present a risk of jamming in pulleys.

Any area of the control line exposing the core (fig2) is grounds for immediate grounding of the aircraft until repairs are carried out.

Control lines with Haemorrhaging will typically be replaced under warranty however an attempt to restore the rope is suggested if there is no broken strands in the core or sheath of the rope.
